Cases by Bosch Diesel Specialist with the JLM Diesel Particulate Filter Cleaner

The following data & case results were compiled by a Bosch Diesel Specialist in the United Kingdom. In these case reports we briefly describe 4 cases of modern diesel cars that came into their workshop with serious DPF problems. All of the tested vehicles are used on short drive cycles.

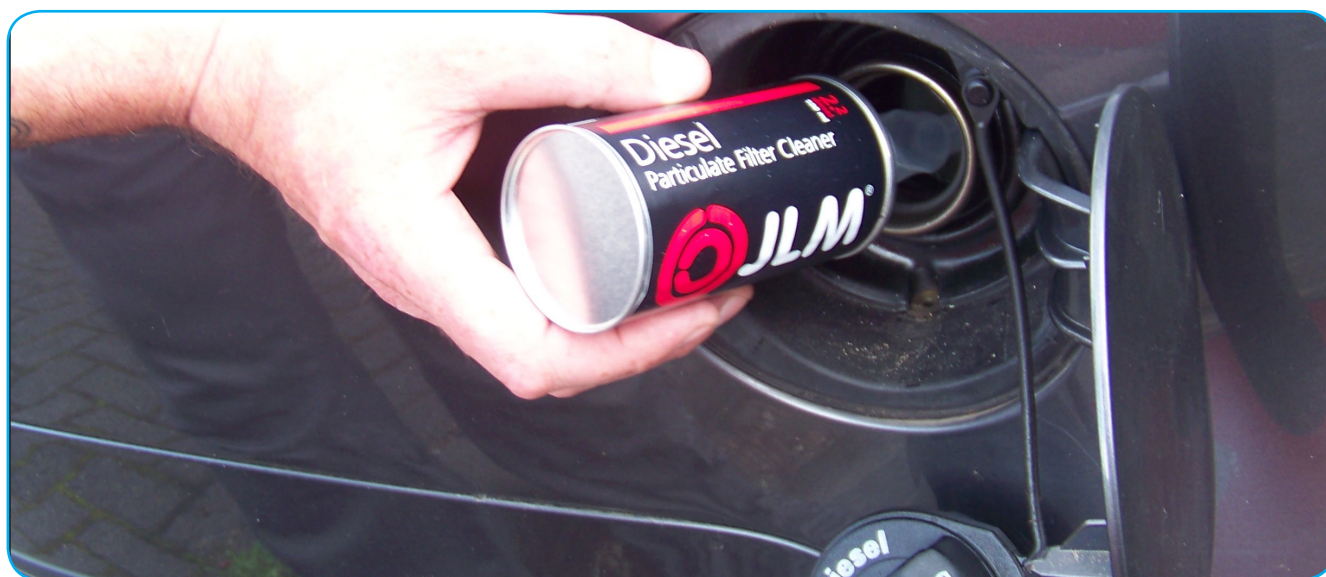
Case 1 - Chevrolet Captiva

Make	: Chevrolet Captiva	Action	
Engine	: 2.0 liter Diesel		100ml of JLM DPF Cleaner added to a full tank of fuel.
Year	: 2008		Vehicle rechecked when complete tank of DPF fuel used.
Odometer	: 47300 Miles (76.121 km)

Idle 800rpm	DPF pressure sensor	4 kpa
2000rpm	DPF pressure sensor	17 kpa
4000rpm	DPF pressure sensor	47 kpa

Idle 800rpm	DPF pressure sensor	0 kpa
2000rpm	DPF pressure sensor	0 kpa
4000rpm	DPF pressure sensor	0 kpa

Diagnostic note - Last regeneration 547 km.

In all 4 test cases the problems were resolved by simply adding 100ml of JLM DPF Cleaner into the tank and driving until the tank was empty again, roughly 500 km on average.

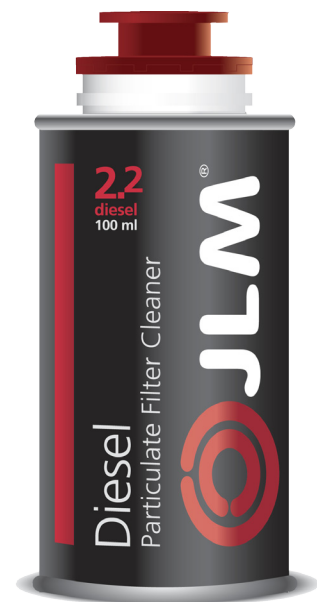
After Treatment

Vehicle rechecked when complete tank of DPF dosed fuel used. Only data we could read was that the DPF filter was 13 % full. Warning light was off and no warning message.
